Debris/Ice/TPS Assessment and Integrated Photographic Analysis of Shuttle Mission STS-79

**DEBRIS/ICE/TPS ASSESSMENT
AND
INTEGRATED PHOTOGRAPHIC ANALYSIS
OF
SHUTTLE MISSION STS-79**

16 September 1996

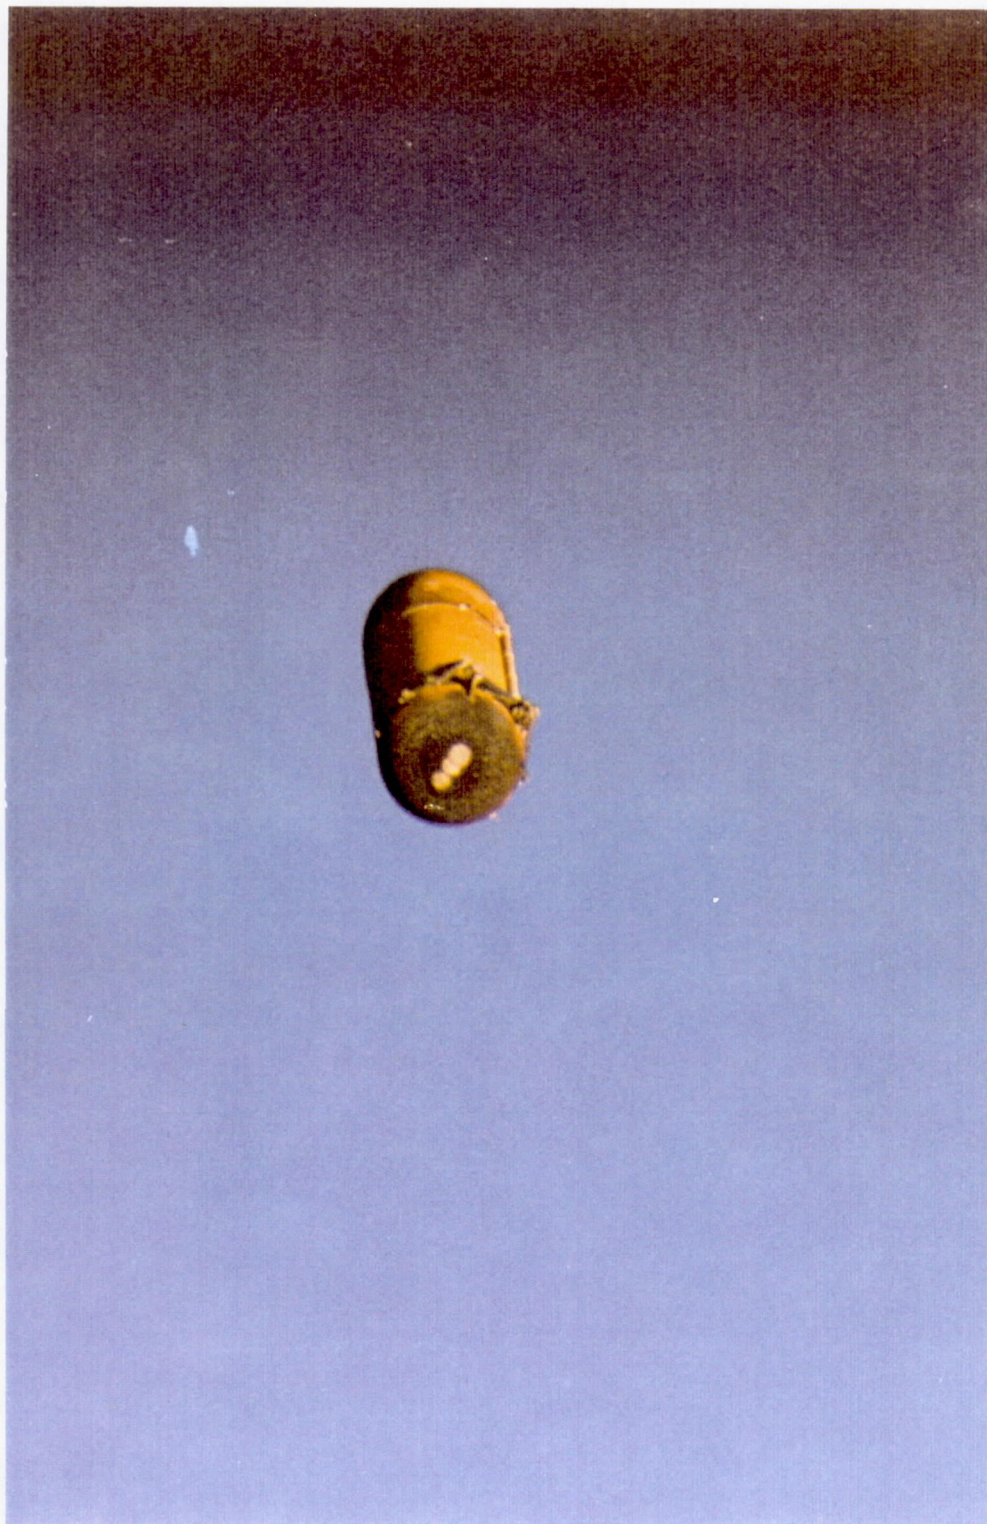
Photo 10: ET After Separation

The aft dome exhibited numerous small "popcorn" type divots/erosion and a mottled charred appearance, none of which were considered anomalous.

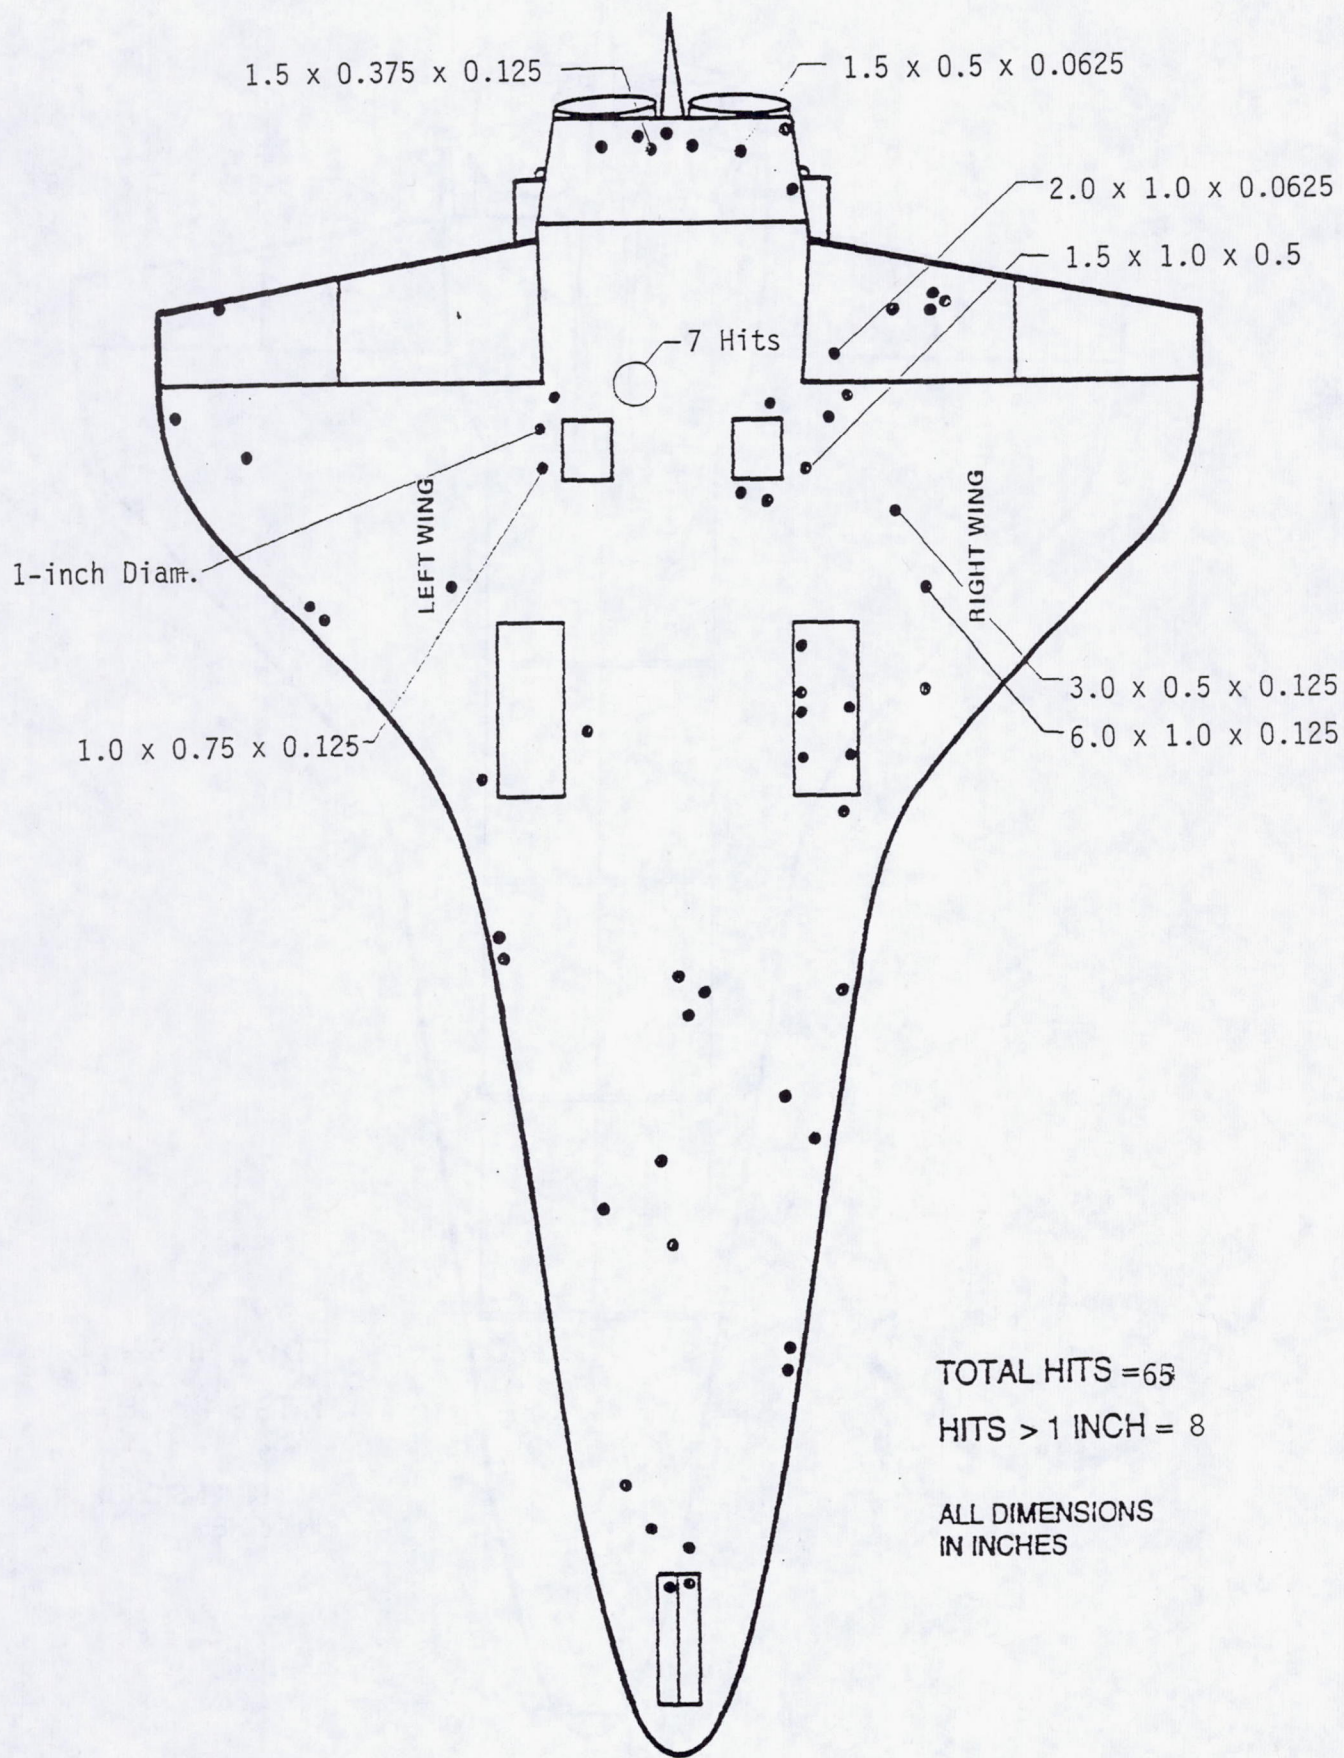
Figure 3: Orbiter Lower Surface Debris Map

The Orbiter lower surface sustained a total of 65 hits, of which 8 had a major dimension of 1-inch or larger. The largest lower surface tile damage site was located outboard and aft of the right main landing gear door and measured 6.0-inches long by 1.0-inches wide by 0.125-inch maximum depth. The damage was most likely caused by an ice impact from the ET LO2 feedline bellows and support brackets.

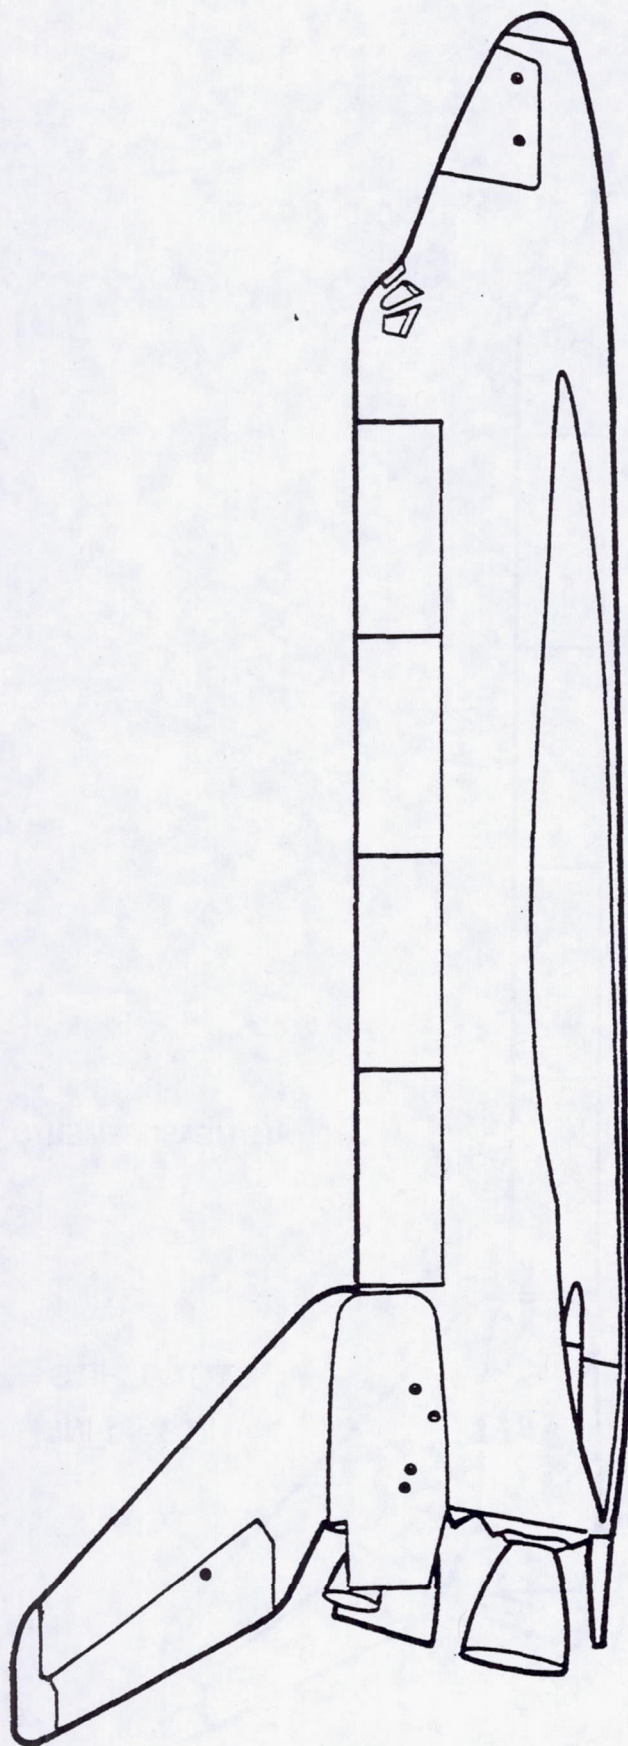
Figure 5: Orbiter Right Side Debris Map

TOTAL HITS = 7
HITS > 1 INCH = 0

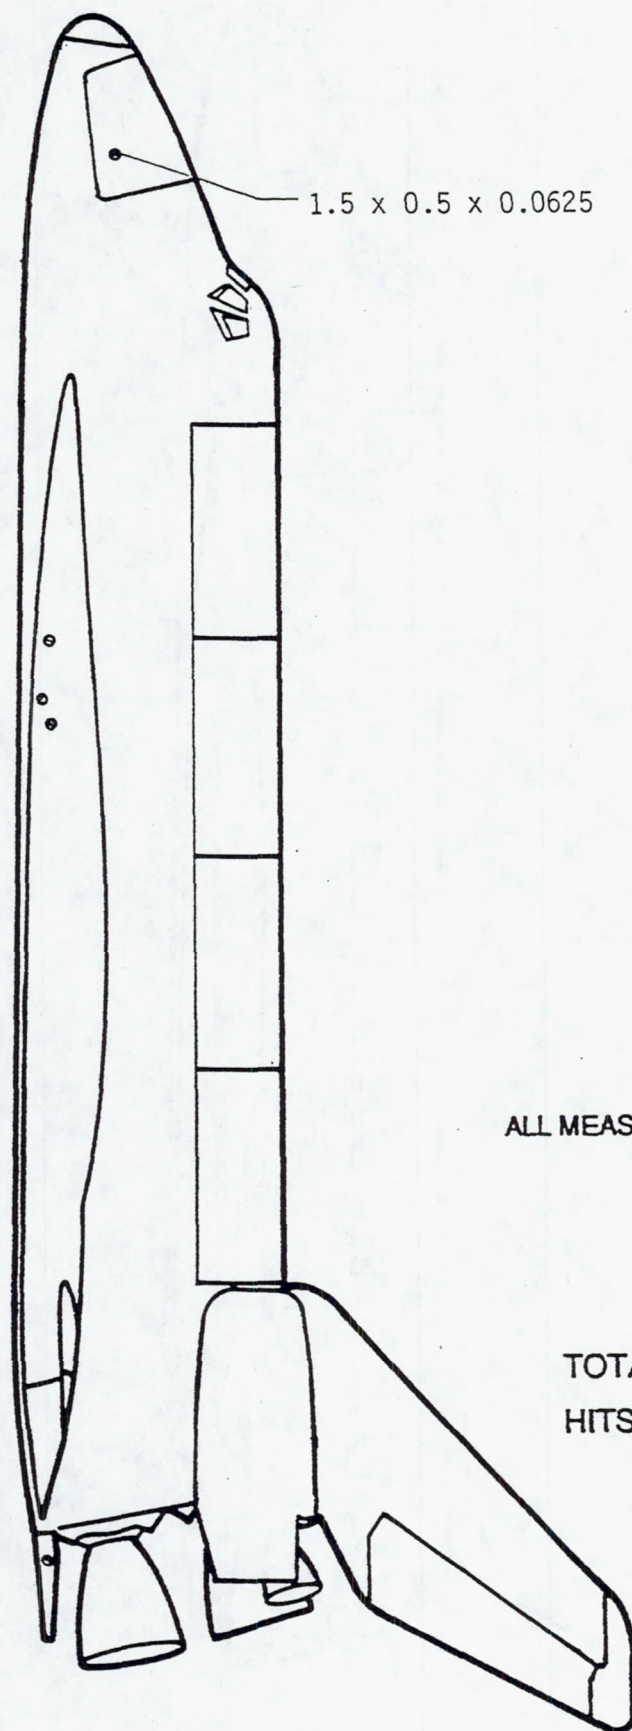
Figure 6: Orbiter Left Side Debris Map

TOTAL HITS = 4
HITS > 1 INCH = 1

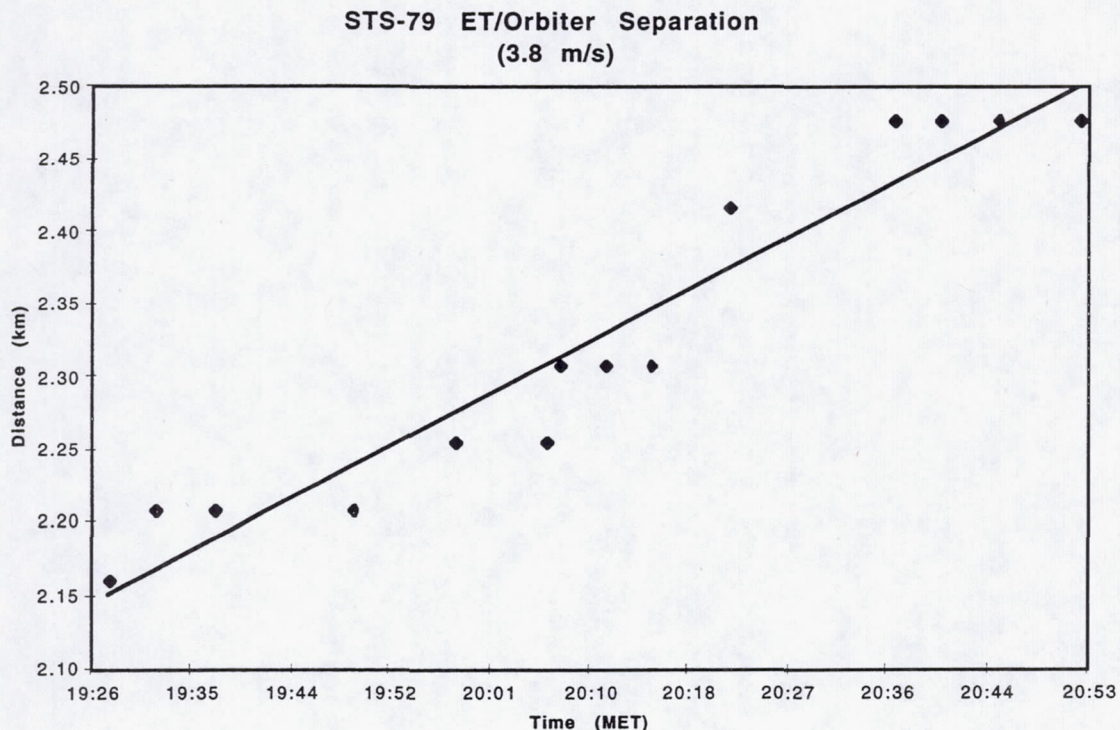
Figure 2.4.2 (B) ET Separation Velocity

The distance of the external tank was calculated over a fourteen-frame sequence using the handheld photography. The external tank was calculated to be a distance of 2.2 km away from the Orbiter at 19:28 MET. The tank was calculated 84 seconds later (20:52 MET) to be at a distance of 2.5 km. The tank separation velocity was determined to be 3.8 m/s. The separation velocity was similar to previous mission measurements. The tank tumble rate was determined to be 1.1 deg/sec. The roll rate of the ET was too small to measure during the 84 second acquisition period of the handheld photography.

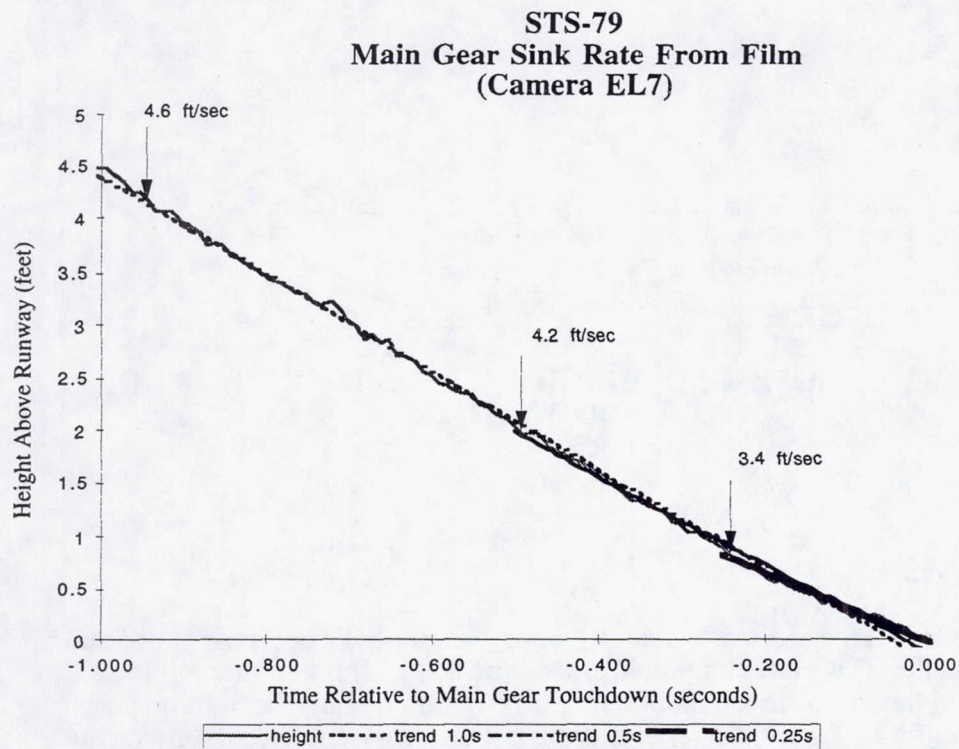
FIGURE 2.6.1(A) MAIN GEAR HEIGHT VERSUS TIME PRIOR TO TOUCHDOWN (FILM)

The measured main gear sink rate values were found to be below the maximum allowable values of 9.6 ft/sec for a 211,000 lb. vehicle and 6.0 ft/sec for a 240,000 lb. vehicle (the landing weight of the STS-79 Orbiter was reported to be 215,000 lb.). The sink rate measurements for STS-79 are given in Table 2.6.1. In Figure 2.6.1(A), and 2.6.1(B), the trend of the measured data points for the film image data is illustrated.

Prior to Touchdown (1/4 Second)	Sink Rate: Film
Main Gear	3.4 ft/sec
Nose Gear	4.0 ft/sec
